Optical haze – a consumer’s perspective

In this paper **Colin Cass** examines the surface effect found on some polished porcelain tiles that has been termed “optical hazing”. It is an effect that is considered undesirable by many consumers and it therefore leads to complaints, some of which end up in complex litigation because the effect cannot be seen when the tiles are tested for surface quality according to ISO10545. Colin recently presented this paper at Qualicer 2010.

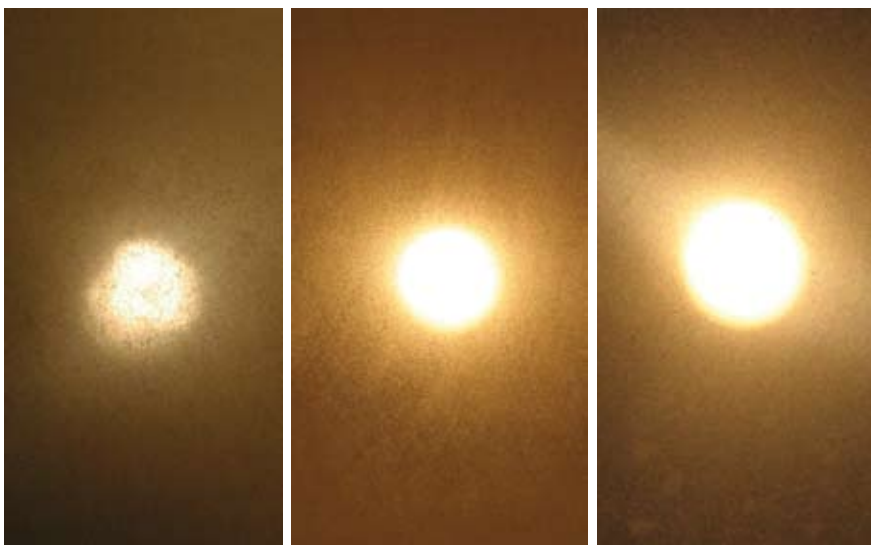
ABOVE Photo No. 2. Note the shadow line on the left becomes hazy about half way down. This localised loss of reflectivity is being called optical hazing in the tile industry

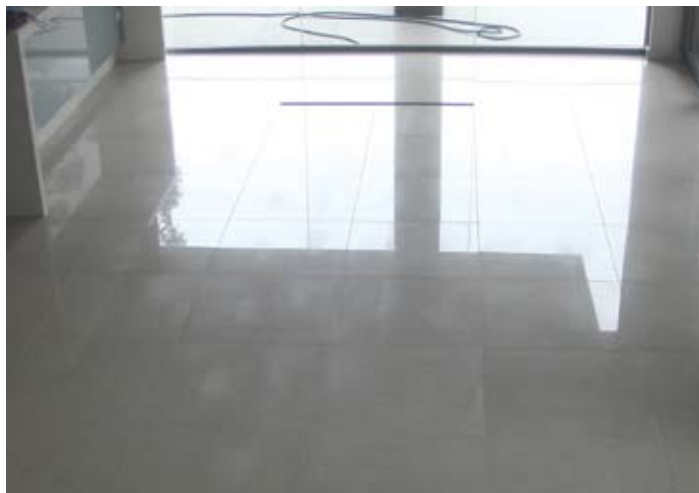
Photo No. 3 The cloudy marks on the tiles in the shaded area typifies the complaint being called "optical hazing" The tiles have a slight travertine vein running east-west the opposite direction to the hazing

There is some evidence that shadowing and optical hazing could be a reverse manifestation of the same effect, although they are not usually visible in the same tiles. **Photos 3 and 4** show both problems in the one consignment, however, the complaint is usually one or the other, only occasionally is it both. The tiles in photos 3 & 4 were laid in a unidirectional manner because they had linear pattern in the double charged layer, (a mock vein cut travertine pattern). The shadowing and hazing on the tiles seen in photos 3 & 4 always ran at 90 degrees to the pattern in the tiles. This could account for why the undesirable surface effects on this floor all went in the same direction. The effects often run at 90 degree to each other where plain coloured tiles have been used.

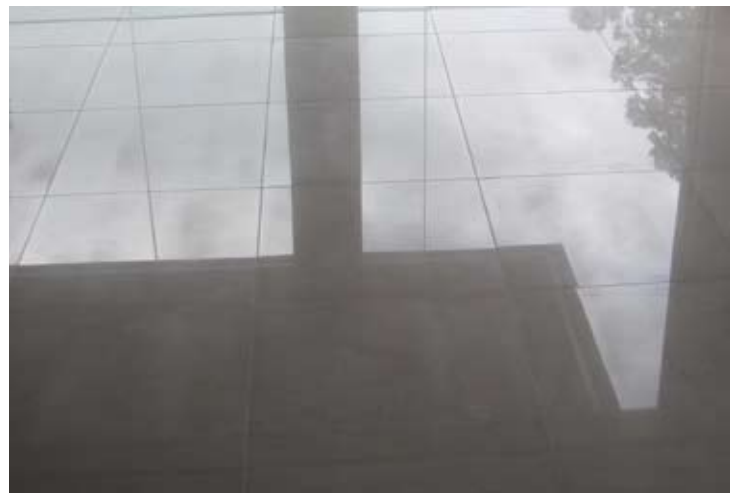
Photo No. 4, in the same room as photo No. 3 shows a typical complaint of "shadowing" in the reflected light

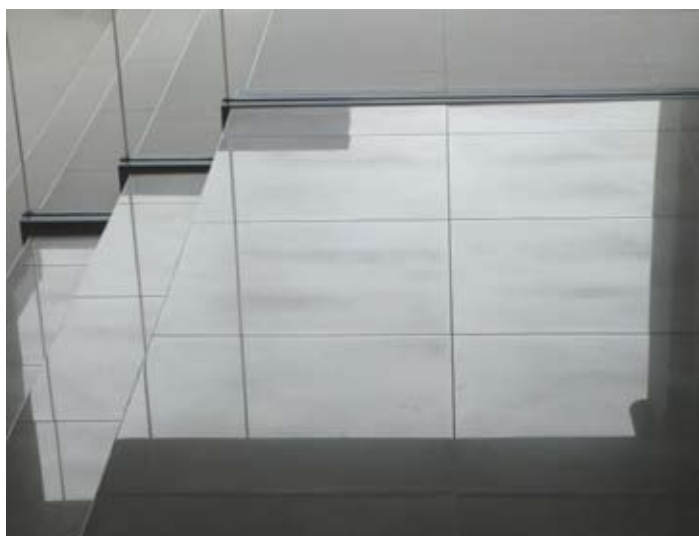
Photo No. 5 shows shadows that appear to be consistent with Sousa's static head polishing time modelling.¹

The above light lines indicating the areas on the surface that have the highest gloss, equate very closely with the lines of shadowing seen in **photo No. 5**.

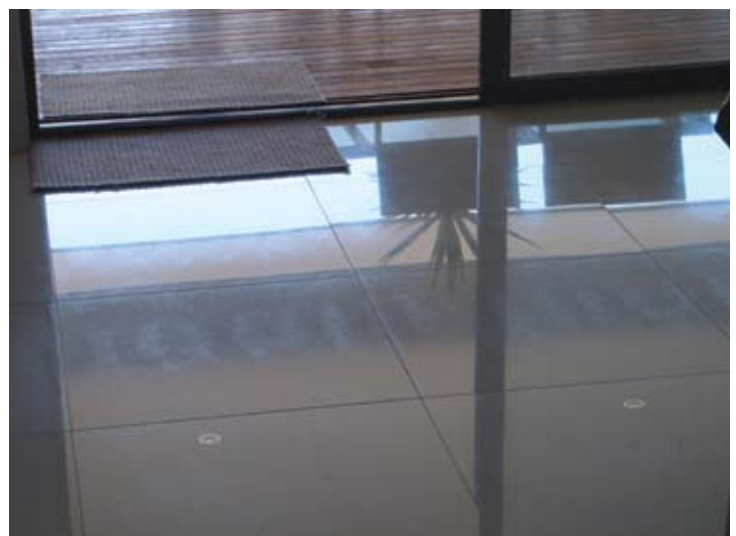
Photo No. 6 shows typical factory applied sealer marks in the central shadow beside the reflected natural light

This possible link between polishing time and regular effects on the surface of the tiles should not be confused with the effect seen in **photo No. 6** where the pattern on the surface of the tiles is believed to be related to the mechanical rotational application (or misapplication) of sealer to the surface of the tiles after polishing is complete.

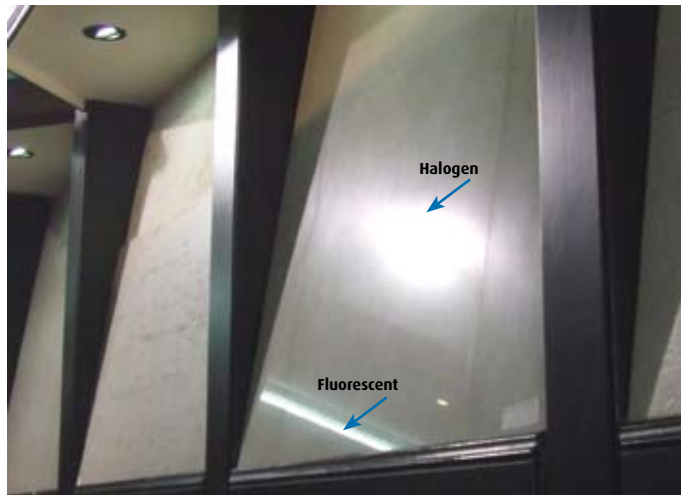
Photo No. 7 shows haze around a halogen reflection but no haze around a fluorescent reflection

None of the effects in **photos 1 to 6** are visible when the tiles are tested according to of ISO10545 part 2 section 7 "Surface quality", that is, from a distance of 1 metre in 300 lux fluorescent light. In fact, all but the effects seen in photo No. 1 require low angle natural light and they are not generally visible in fluorescent (or incandescent) light as shown in **photo No. 7**.

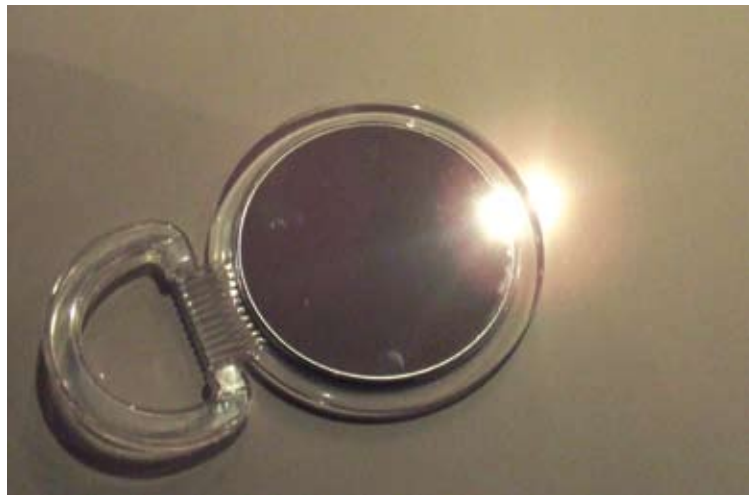
Photo No. 8. The halogen down light reflects similarly off the polished tile and the mirror producing haze

halogen light reflected off both a mirror and a tile can be seen in **photo No. 8**. There is a tendency for sales staff to “over-sell” polished porcelain as a high gloss maintenance free flooring material leading to consumer expectations being raised to the point where perfection is expected. This has led to many hundreds of complaints in Australia with most retailers now developing policies and procedures for handling polished porcelain reflectance complaints. This includes signs in showrooms, disclaimers on invoices and brochures explaining optical hazing as an inherent feature of some tiles. These approaches are likely to have limited legal status and they don’t meet the primary objective of having satisfied customers. Arbitrators of disputes in these matters have already found in favour of customers on the grounds that the surface effects visible are significant enough to warrant replacing the tiles regardless of whether the standard test passes them as first quality.

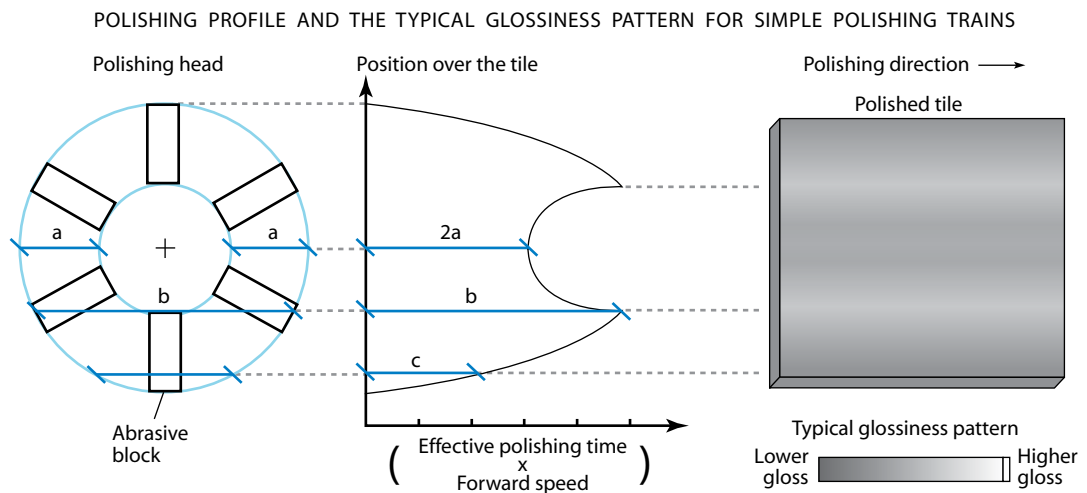
Figure 1. Polishing time modelling for a static head polishing machine

The problems could be linked to the polishing procedures used in the factory. The linear marks associated with “shadowing” that are causing complaint (occasionally the hazing also takes this linear form) appear to be regularly aligned with the zones that receive the longest contact with the grinding and polishing stones. (Fickerts) This feature can be possibly be associated with **figure 1** taken from the paper of F. Sousa, J. Aurich, W. Weingaertner, & O. Alarcon titled “Analytical determination of the distribution of polishing time over the surface of polished tiles”.³

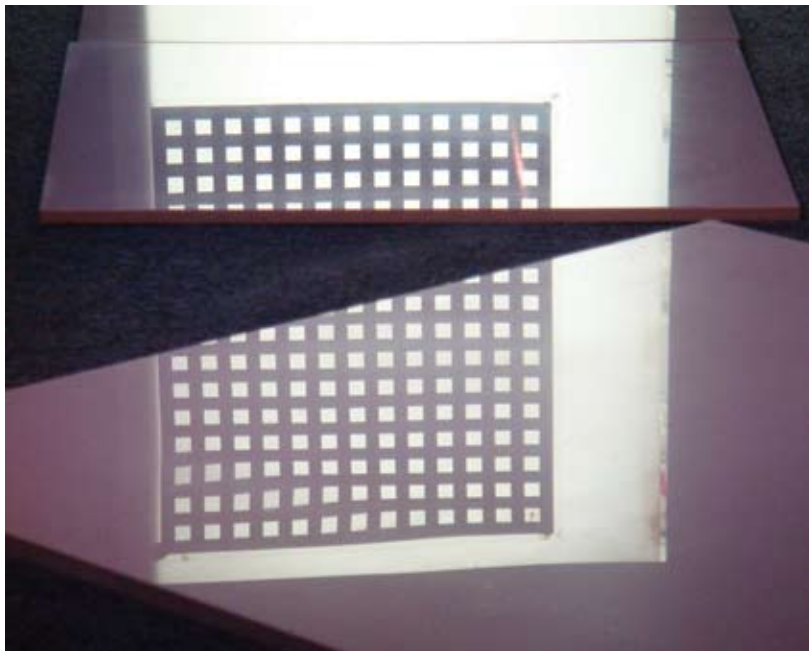
Photo No. 9. The perfect squares on the light box are distorted in their reflection off the polished tiles showing the surface of the tiles is not flat

That there are parts of the surface of the tiles that receive more grinding and polishing time can be regarded as probably leading to micro deviations from a perfectly true or flat surface. Preliminary investigations undertaken at the University of New South Wales indicated shadowing was related to a 4 to 7 micron deviation in plane. Obviously, such minor deviations in flatness should not be considered a defect in the tile. However, this does open up an area of study that could “cast light” onto the causes of hazing and shadowing on the surface of polished porcelain tiles. **Photo No. 9** shows that the perfect grid of the squares in the light box is reflected with some distortions from the surface of the polished porcelain tiles.⁴ This shows that the surface of the tiles is not truly flat. Finding regular visual deviations that coincide with unwanted

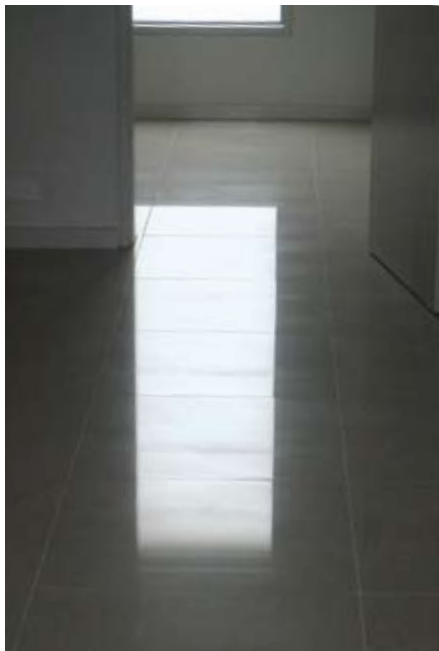
Photo No. 10. Shadowing on a floor in Sydney before treatment

An example of a shadowing problem before and after the de-glossing and re-glossing treatment can be seen in **photos 10 & 11**.

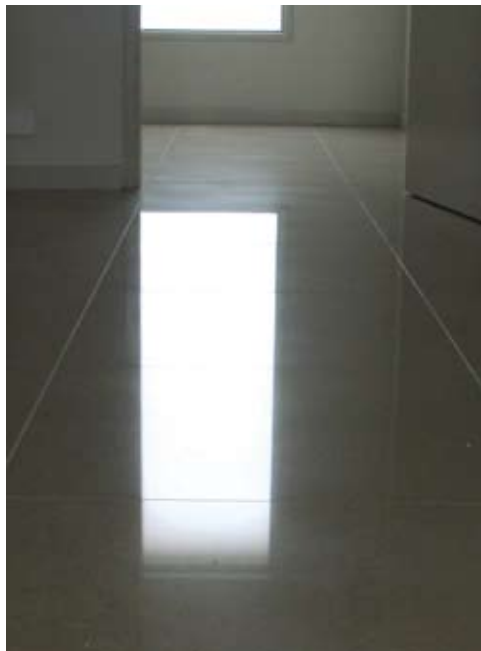
Photo No. 11. The same area after de-glossing and re-glossing treatment. Note only the 4 tiles out from the doorway were treated as a test to meet customer satisfaction.
